Cambria Community Healthcare District

**Facility Condition Assessment
Final January 25, 2022**

This Facility Condition Assessment for the Cambria Community Healthcare District Offices and Crew Quarters reviews the current physical conditions of the facility and develops costs to repair or replace the building. The building currently houses the CCHD Administrative Offices, CCHD Crew Quarters, and Community Health Centers tenant spaces.

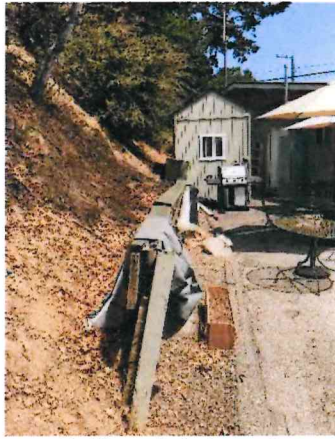
Failing debris wall

- Existing debris wall has failed. Recommend installing concrete k-rail (or similar) to protect facilities and equipment.
 - See discussion of PG&E service to the building in the Plumbing, HVAC, and Electrical section above.

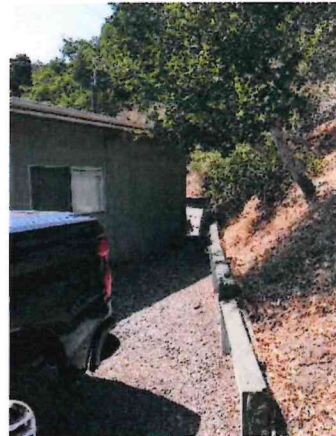
Debris wall behind facilities

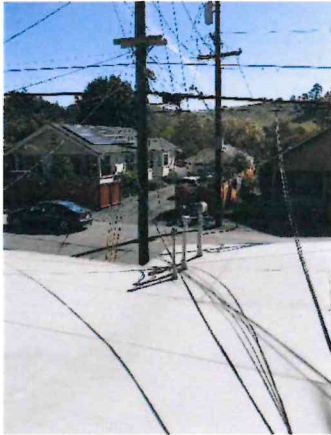
Newer Roofing

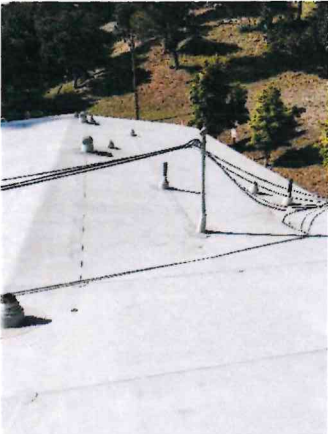
Newer Roofing

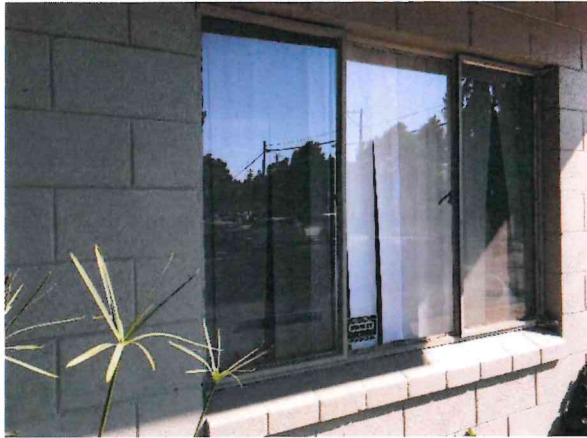
Window doesn't close properly

- **Exterior Envelope.** All windows, storefront entry systems, doors, and hardware are beyond useful life and should be replaced. The roof is a newer single ply membrane in good condition with approximately ten years of life remaining. Some wood siding has moisture damage; unless grading conditions at exterior walls are improved it is likely damage will continue.

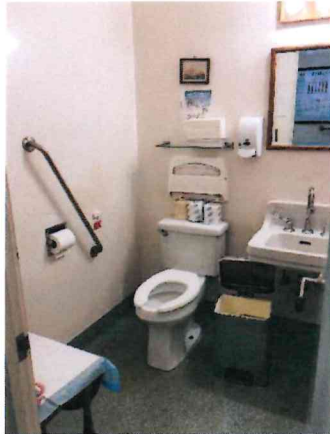
Non-ADA restroom

- **Interior Construction and Finishes.** All interior finishes are beyond their useful life. All doors and hardware are beyond useful life, don't meet current codes and accessibility requirements, and should be replaced. No restrooms meet accessibility requirements; these rooms are too small and will have to be demolished and re-built to meet current requirements. The stairs are open to corridors and do not meet fire code requirements. Additionally, the CCHD should also

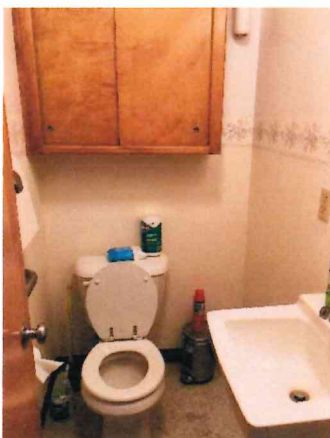
Non-ADA restroom

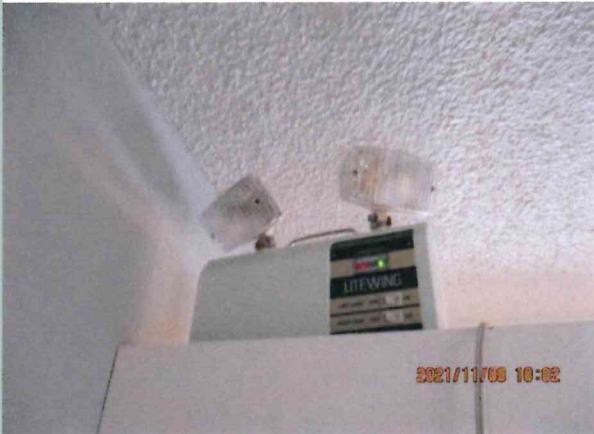
- Emergency lighting system – no observed emergency lighting, except a portable device.
 - Automatic fire alarm and communications – no observed compliant FACP and system.

Emergency lighting

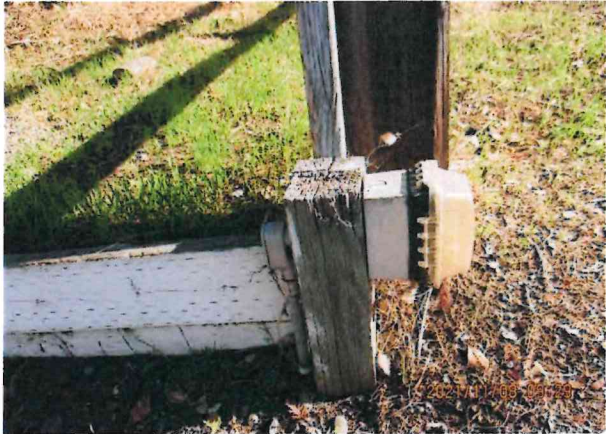
Non-compliant exterior outlet

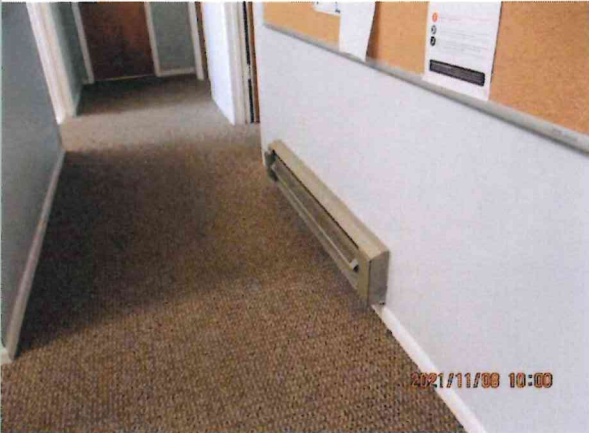
- **Plumbing, HVAC, and Electrical.** There are no functional heating, cooling, or ventilation systems in the facility. Nearly all mechanical, electrical, and plumbing systems appear to be original and are well beyond useful life (or missing) and should be replaced in their entirety.

Non-working wall heater

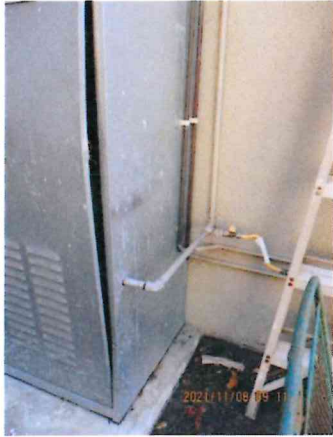
Non-compliant gas connection

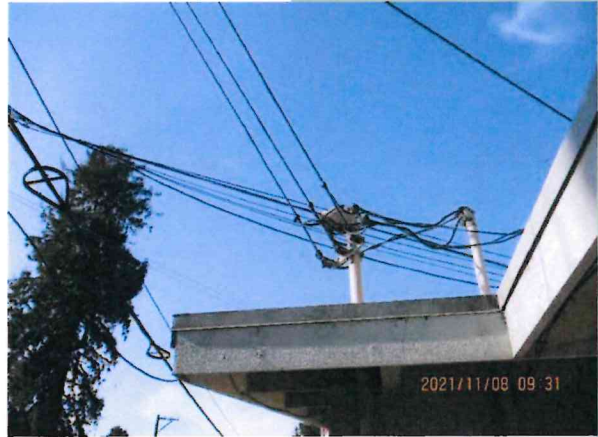
- The building power distribution wiring includes multiple service entrances rated at 120/240Volt 3-phase, 3-wire and associated non-compliant power distribution panels. Nothing short of a complete replacement of the entire system will fix this set of conditions.
- The whole building power system fails to meet the most basic requirements. Hot, neutral, and grounding and bonding issues - Service entrance to connected loads. Only a complete replacement of the system will resolve the variety of code violations and deficiencies.
- Suggest PG&E Utility to investigate and remove pole mounted single phase service laterals; an unacceptable

Electric service hodge-podge of wiring

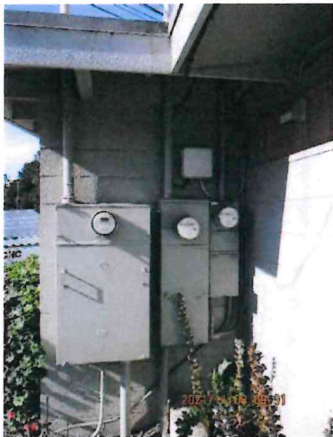
PG&E service nos. 1, 2, and 3

public safety condition - Recommend fast track resolution as soon as possible.

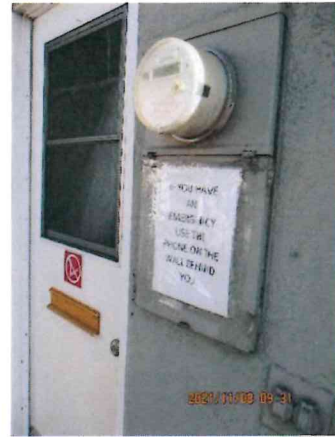
PG&E service no. 4

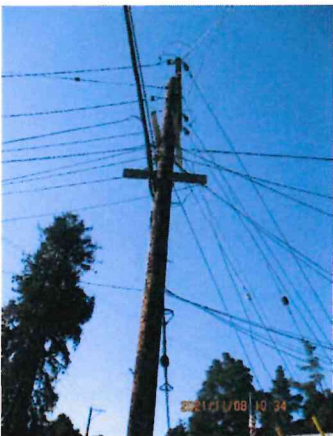
PG&E service pole

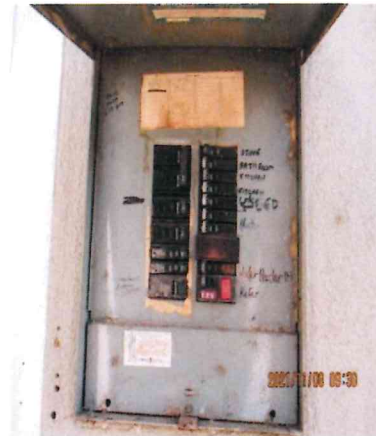
Electrical distribution panel
