## GeoSolutions, INC.

February 7, 2017  
Project No. 10078-2

Subject: **Numerical Slope Stability Evaluation**  
2535 Main Street  
Cambria, California

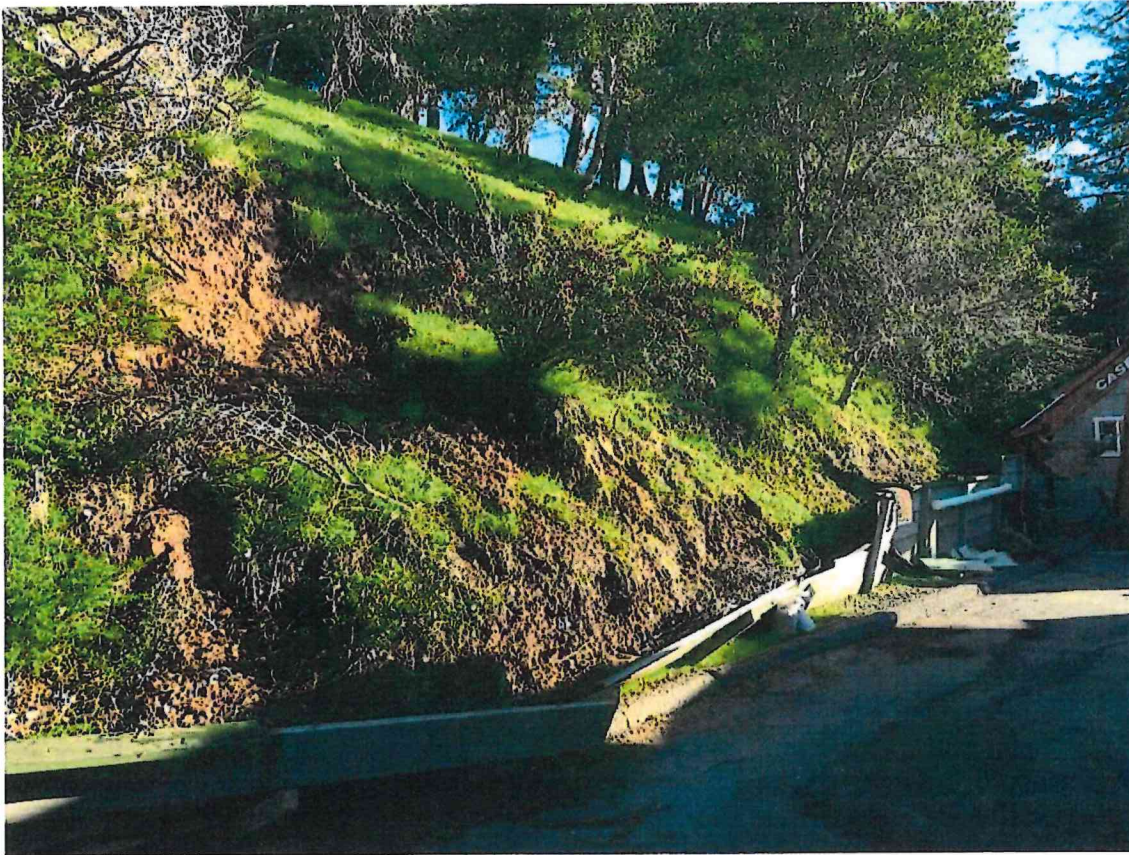
**Figure 4: View northeast of failure of cut slope. Note proximity of building in back to cut slope and failure of wood wall. Trench T-1 was excavated near the building, Trench T-2 was excavated in the slide, and Trench T-3 was excavated just left of the sight of the picture.**

In addition to the recent slope failure, buildings at the site are within close proximity of the cut slope. The building utilized by employees as sleeping quarters is only several feet from the existing cut slope. The potential for an unstable slope to affect this building is very high.

2. As slopes are unstable as currently cut, safety of personnel, equipment, and structures is paramount. It is recommended the small building utilized by personnel as a residence quarters, not be used until slopes can be retained or substantial distance (15 feet) from the building to the toe of slope can be maintained. K-rail is recommended to be installed within the driveway area that does not maintain a distance of 15 feet between the larger on-site building and failed slope as a temporary measure to reduce potential of failed slope material to affect the larger on-site building. Ambulances and other vehicles are recommended to NOT be parked behind the building until retaining structures can be constructed.

3. It is recommended that a civil engineer/general contractor with experience with cut slopes and retaining structures be contacted regarding types of retaining structures that can be established at the site where slopes exceed 2:1 (horizontal:vertical). In lieu of a poured concrete retaining wall, structures such as Redi-Rock stacked block wall may offer mitigation to retaining the slope. Graded options may be considered however, cuts within colluvial material (surface soils) and weathered rock must maintain a maximum slope gradient of 2:1 (horizontal:vertical) or less steep.

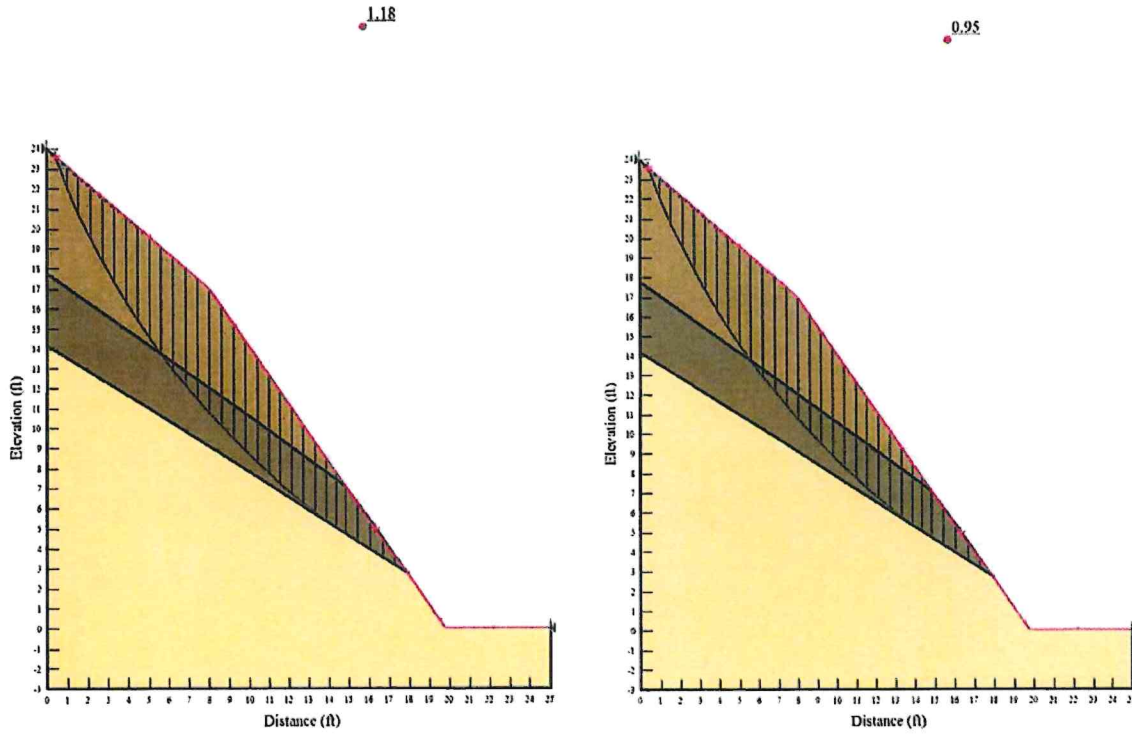
Profile	Static Factor of Safety (standard is 1.5)	Pseudo-Static Factor of Safety (standard is 1.15)
Trench T-1	1.18	0.95
Trench T-2	1.18	1.09
Trench T-3	1.26	1.03

The static stability analyses performed for the existing cut slope configurations as encountered at the site with material collected from three trenches (within the cut slope) shows that the **critical static factor of safety values are below the minimum standard, indicating that they reflect unstable conditions as the slope is now configured.** The minimum engineering standard for static factors of safety is 1.5.

The pseudo-static (seismic) stability analyses performed for the slope configurations shows the **critical pseudo-static factor of safety values are below the minimum standard (1.15), indicating that they reflect unstable conditions.**

Figure 5: Trench T-1, (Static, value of 1.18, pseudo-static value of 0.95)

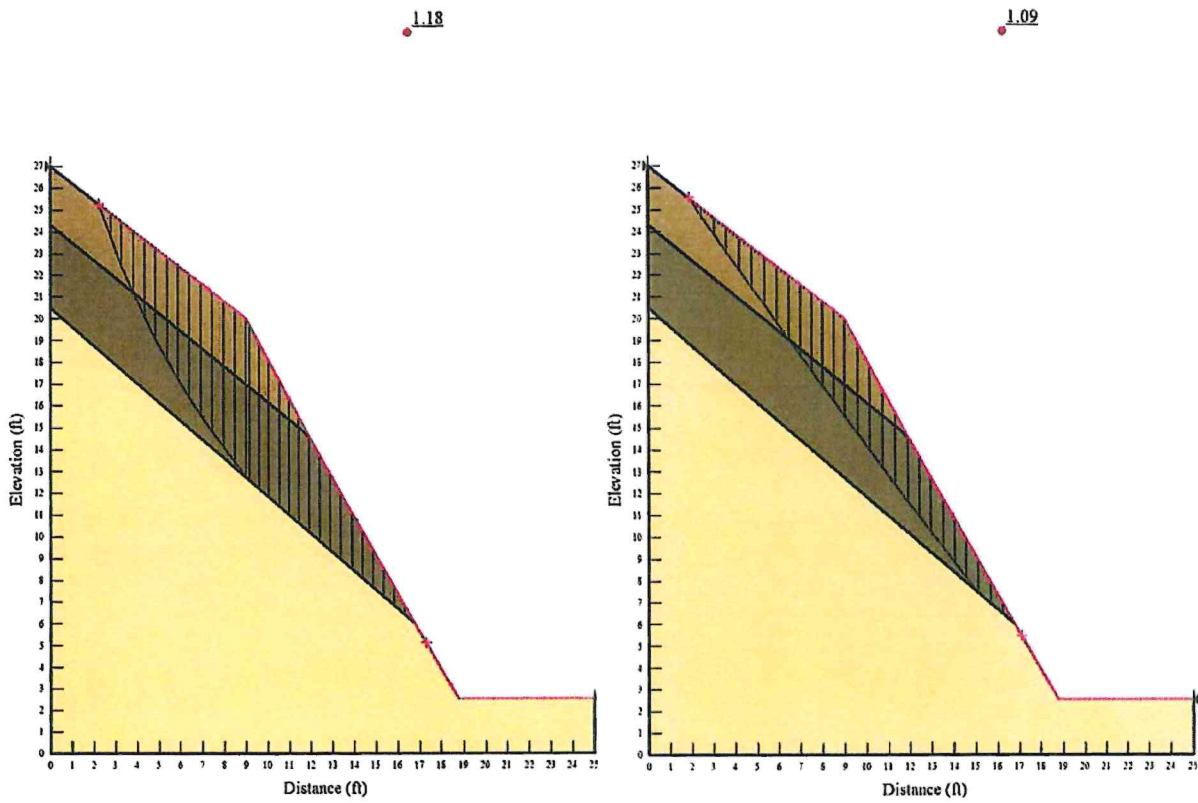
Figure 6: Trench T-2 (Static, value of 1.18, pseudo-static value of 1.09)

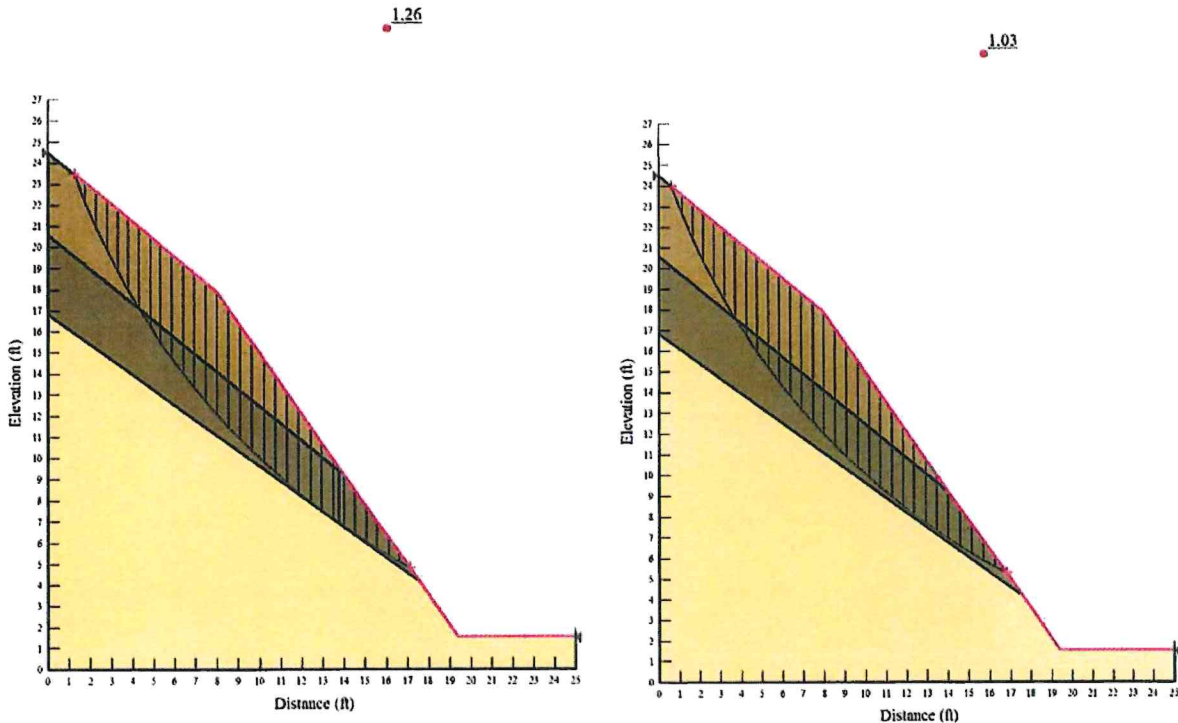
Figure 7: Trench T-3 (Static, value of 1.26, pseudo-static value of 1.03)

Based on the results of the analysis, the cut slope is not stable the current configuration (static values less than 1.5 or pseudo-static values less than 1.15).
