CAMBRIA COMMUNITY HEALTHCARE DISTRICT

CAMBRIA COMMUNITY HEALTHCARE DISTRICT DECEMBER 21, 2021 REGULAR BOARD MEETING MINUTES

Facility Condition Assessment (FCA)

Facility Condition Assessment
Final January 25, 2022

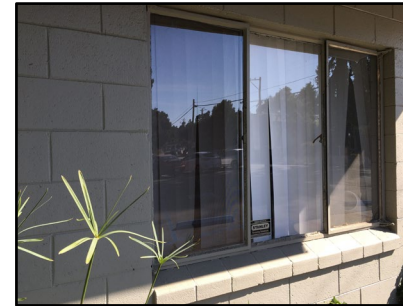
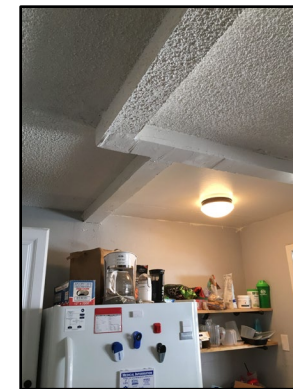
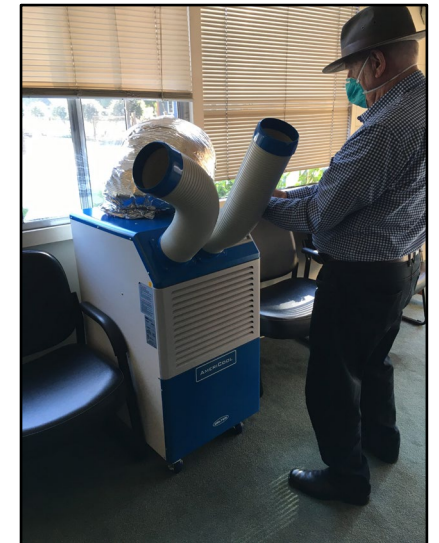
No functioning HVAC systems; electrical system is especially poor

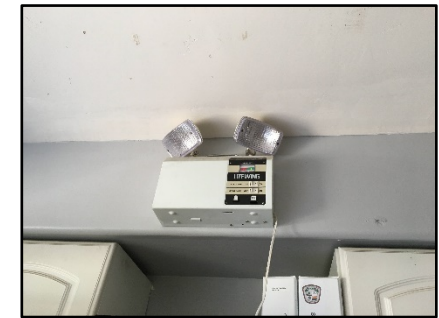
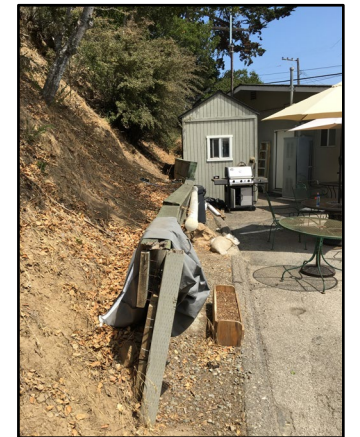
Some areas of debris wall have failed

Some paved areas in poor condition

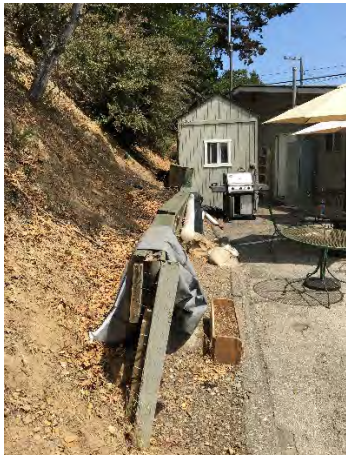
Failing debris wall

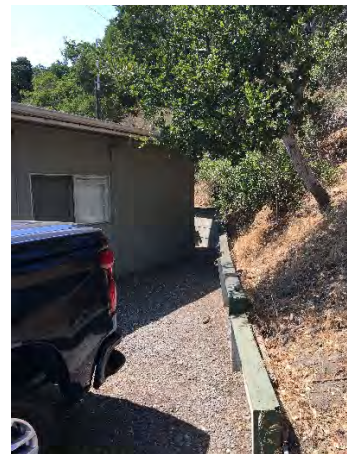
Debris wall behind facilities

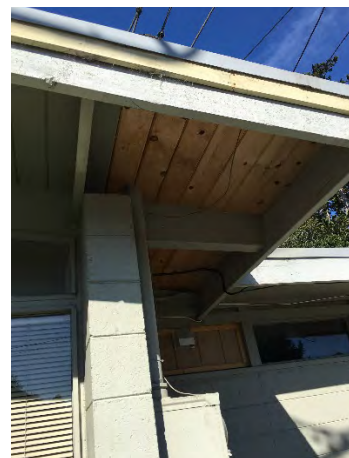
Soffit detail

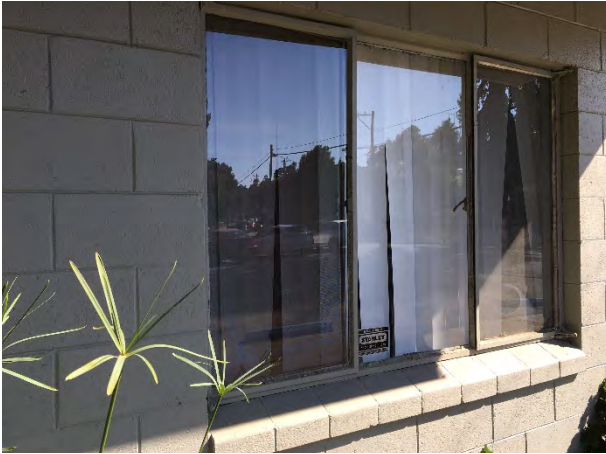
Window doesn't close properly

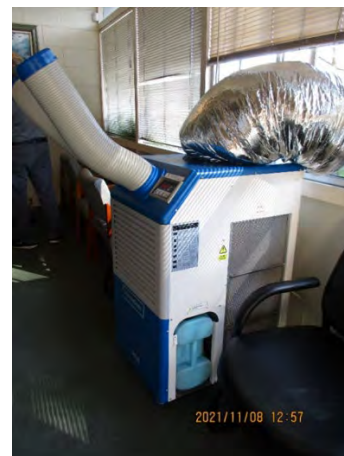
Evaporative cooler at CHC

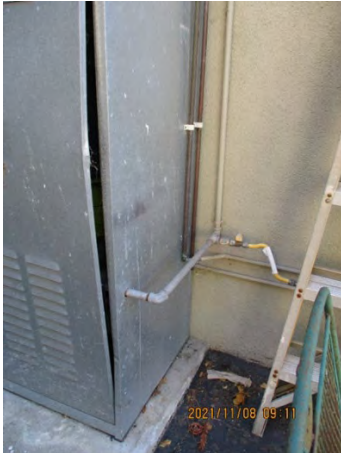
Non-compliant gas connection

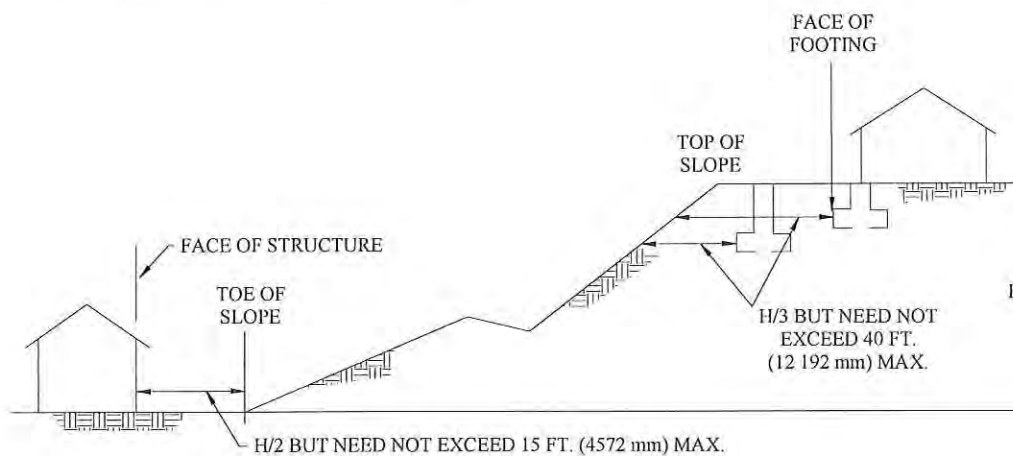
Figure 2: Building Setback Distance

1. The minimum building setback distance from ascending or descending slopes steeper than 3-to-1 (horizontal-to-vertical) but less than 1-to-1 must be maintained.

It is recommended that the buildings at the site maintain a setback distance of 15 feet from toe of slope if retaining structures are not utilized at the property. Figure 2 shows recommended setbacks.

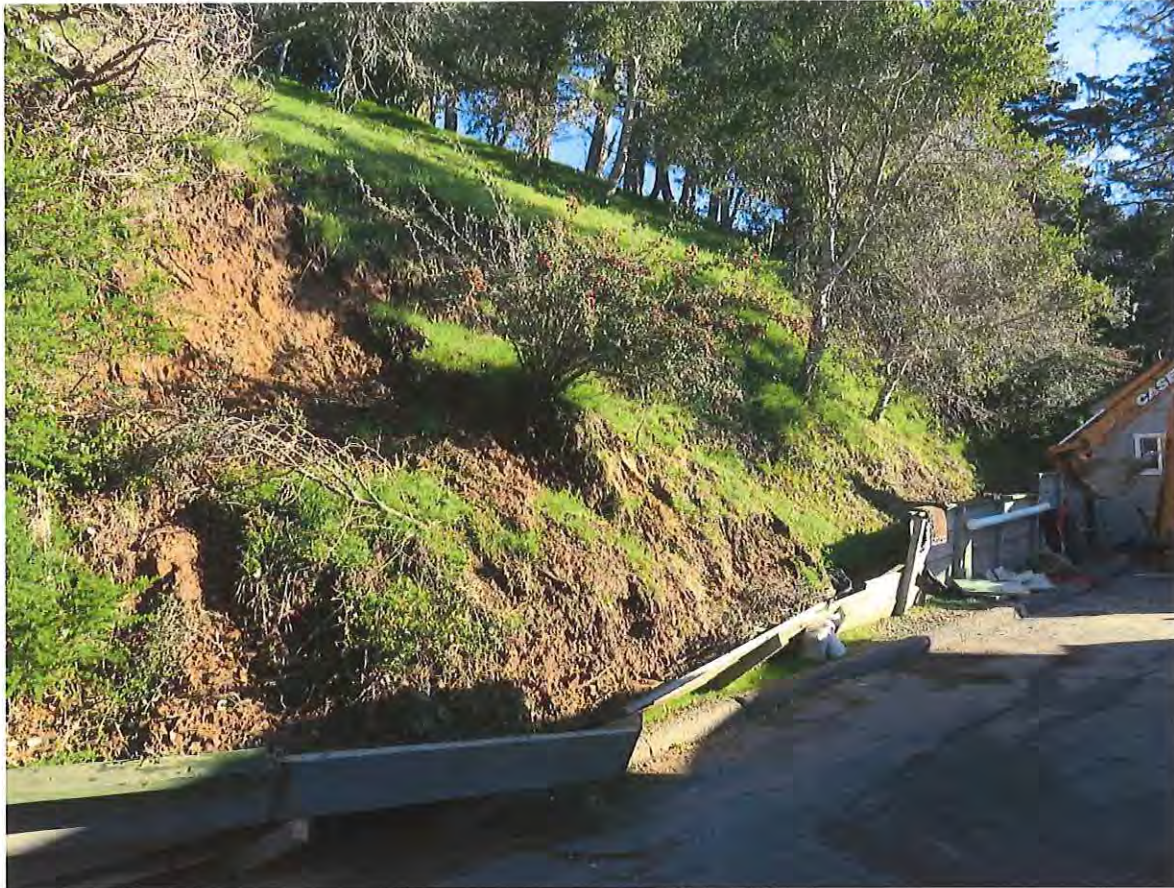
The subject property is located in the community of Cambria, California along the north side of Main Street. The property maintains a relatively flat area on the southern portion of the property where a parking lot and two buildings are situated. One building is utilized as a health center, the other building is utilized as housing for medical personnel. A slope rises along the northern portion of the property that extends beyond the property boundary. A recent slope failure prompted the undersigned to assess the slope as it is currently configured. No site topographic map or site map was available for this investigation. Figure 3 depicts an aerial photograph of the site and trenching locations. Figure 4 depicts the failed slope at the site.

Figure 4: View northeast of failure of cut slope. Note proximity of building in back to cut slope and failure of wood wall. Trench T-1 was excavated near the building, Trench T-2 was excavated in the slide, and Trench T-3 was excavated just left of the sight of the picture.

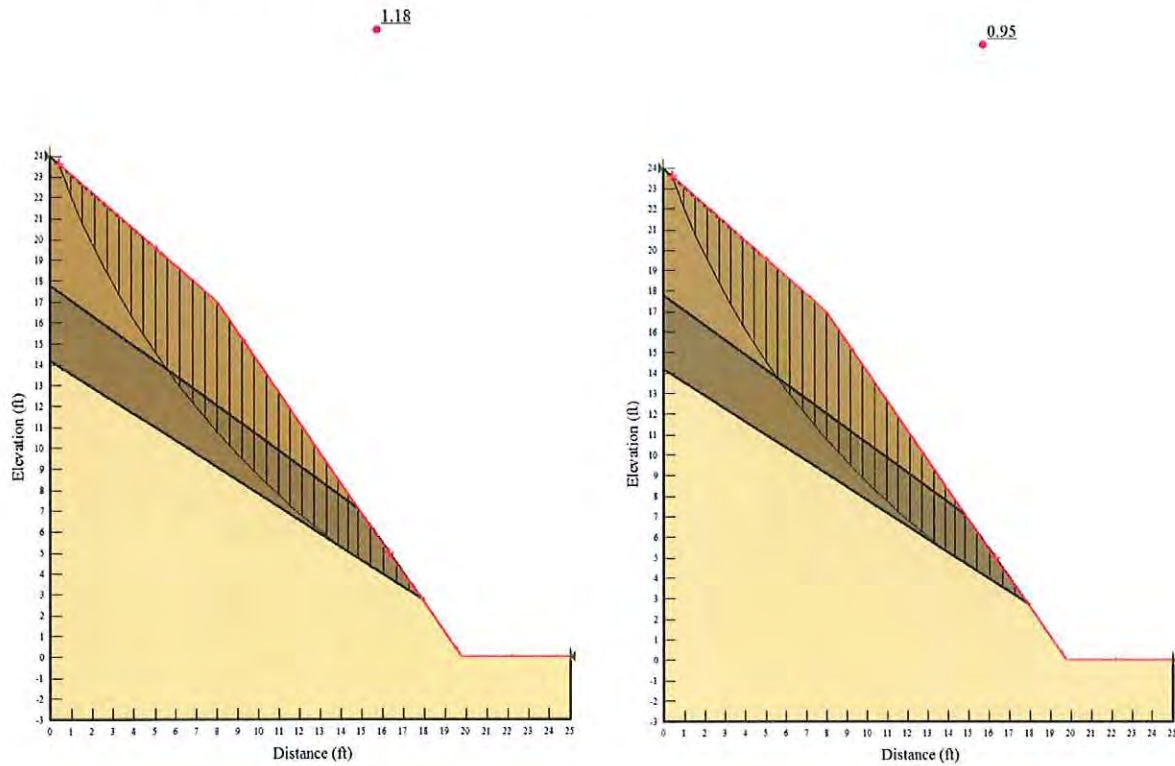
The pseudo-static (seismic) stability analyses performed for the slope configurations shows the **critical pseudo-static factor of safety values are below the minimum standard (1.15), indicating that they reflect unstable conditions.**

Figure 5: Trench T-1, (Static, value of 1.18, pseudo-static value of 0.95)

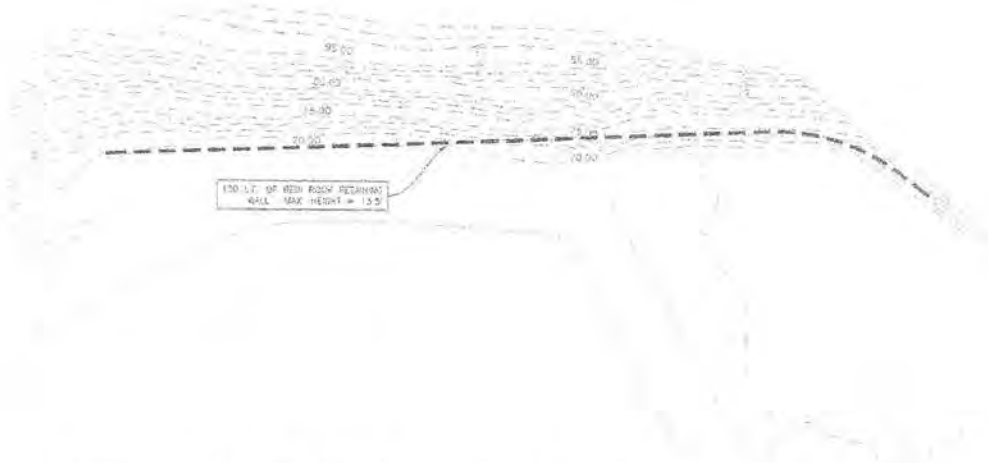
Due to the existing unstable slope, it has been recommended by the engineering geologist that a retaining structure be constructed where site slopes exceed 2:1 (horizontal: vertical). In lieu of a conventional poured in place wall, a stacked wall may offer mitigation of the retaining slope. For the purpose of this analysis, a Redi-Rock stacked retaining wall system was analyzed. An initial alignment was analyzed that follows the approximate existing wood retaining wall and existing toe of slope. The proposed wall alignment and typical section view are shown below in Figure 1 and Figure 2 for reference. Structural wall calculations were performed using MSEW wall software and the Redi-Rock retaining wall design software provided by the manufacturer.

Figure 1. 13.5' Redi-Rock retaining wall alignment with minimal setback.

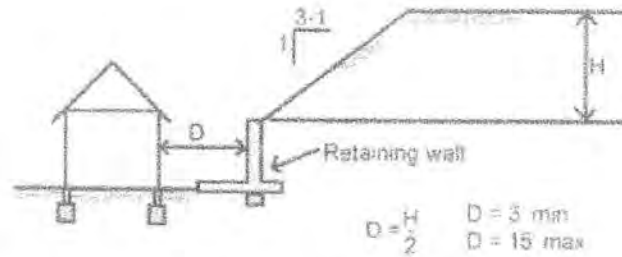
Figure 3. Retaining wall setback requirements.

Figure 3 above illustrates the setback distance behind the existing building. This minimum setback is not consistent with CBC requirements (shown in Figure 3) which requires the distance between the building and the toe of a wall to be a minimum distance of $H/2$ which in the area is approximately 9' feet.

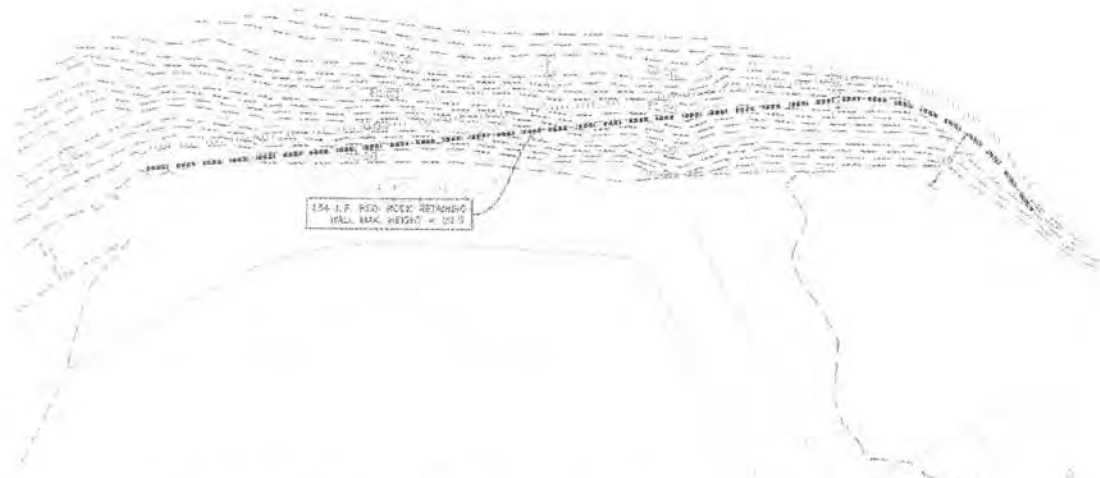
Figure 5. 22.5' Redi-Rock retaining wall alignment with 9' setback.

For the purposes of maintaining the necessary setback from the existing building, a 22.5' tall Redi-Rock wall with a 9' setback is analyzed which would notably allow for vehicle clearance between existing buildings and the retaining wall. Most notably, this design option would require major excavation of the slope due to an increased wall batter of 27.5° necessary based on our structural calculations.

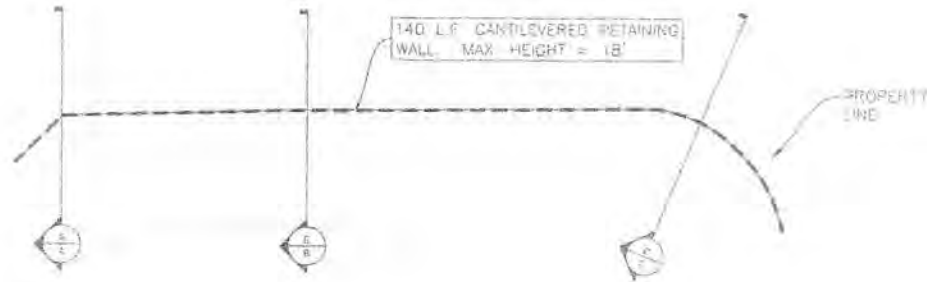
In addition to the stacked block wall system, Coast, Inc. reviewed and analyzed the feasibility of a conventional poured in place retaining wall design. The alignment shown below in Figure 6 illustrates a setback distance of 9' away from existing structures as dictated by CBC.

Figure 6. Proposed cantilever retaining wall location relative to existing structures.

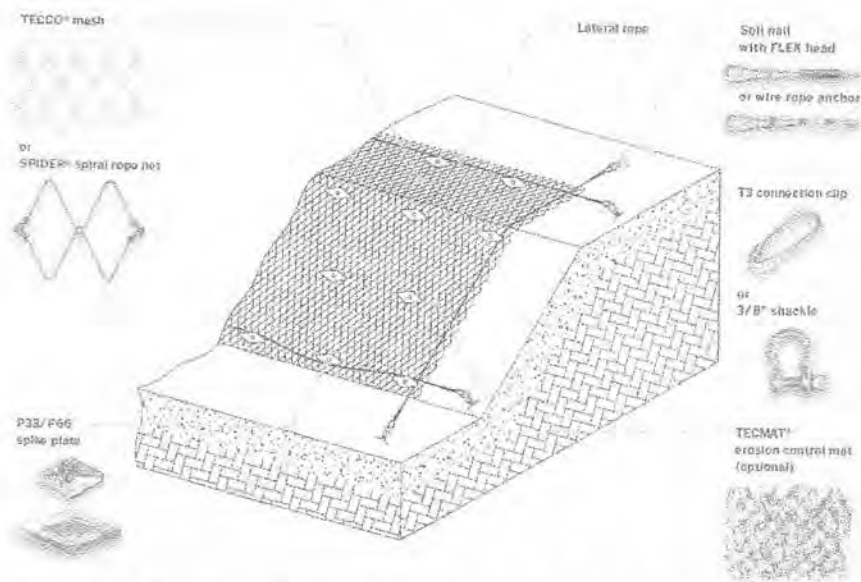
The TECCO® SYSTEM³ is an engineered slope protection and stabilization system which is used to stabilize steep slopes of unconsolidated or rocky material and to prevent loose or weathered material from settling further down the protected slope. The mesh is attached to the ground by system spike plates. By tightening the nuts on the spike plates, the slope stabilization system is pretensioned to a predefined force. This system can be installed around larger trees but some vegetation removal may be required.

Figure 10. Example of slope stabilization with the TECCO® SYSTEM³

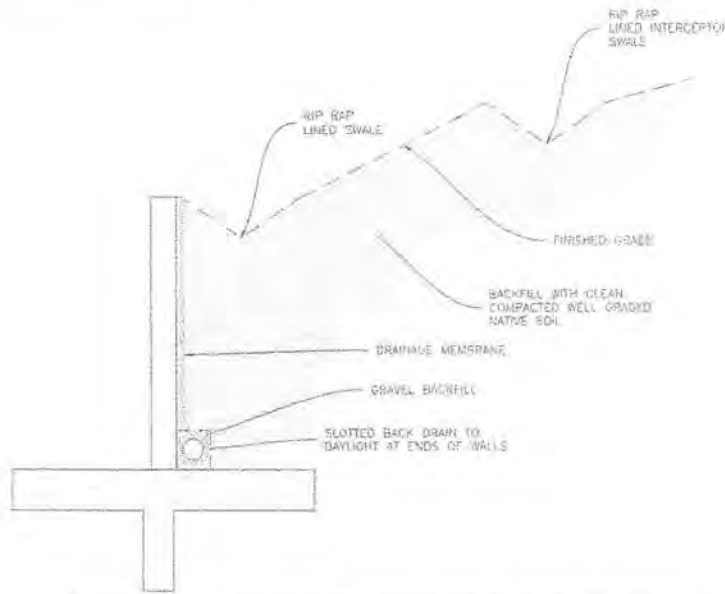
A principal cause of retaining wall/slope failure is the additional loading imposed by an increase in the water content in the material behind the wall or slope. These conditions can greatly increase the lateral loads behind the wall/slope and reduce the soil shear strength resulting in failure. To alleviate this, adequate drainage in the forms of subsurface drains, behind wall swales, and interceptor swales higher up the slope should be implemented. These swales are most often rip rap lined earthen channels but can be concrete channels. Collected water is then distributed down and away from the slope through energy dissipation. Concentrated over-slope drainage should be avoided and any collected water should be diverted and discharged away from the slope.

Figure 11. Retaining wall drainage considerations.
